## MEMORANDUM

RE: WWTF Trickling Filter Concrete Dome Cover Condition  
SEH No. RWING 174561 14.00

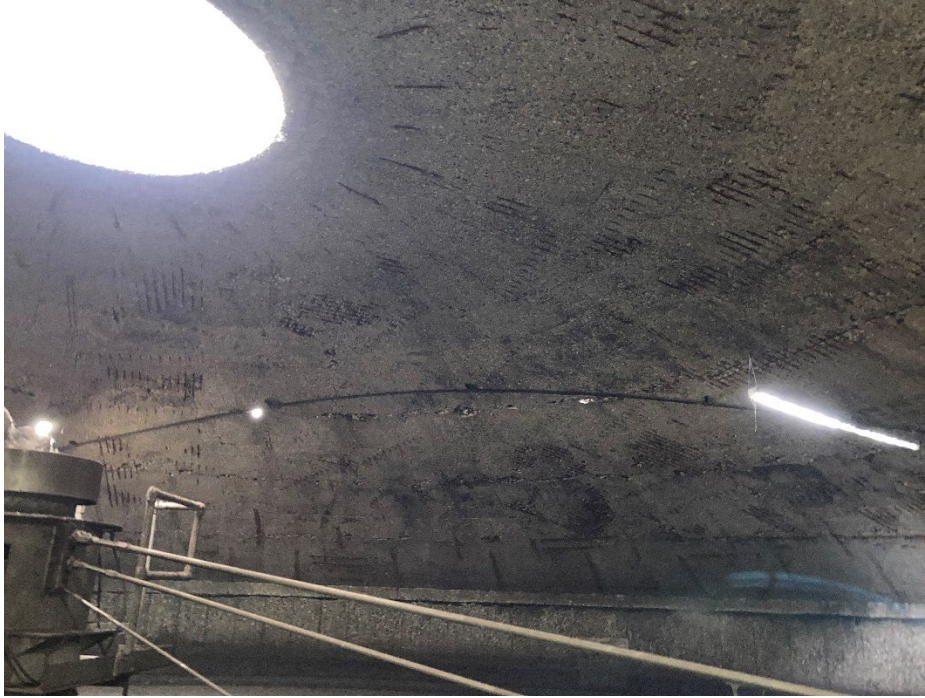
Corrosive moisture and gas as well as freeze/thaw cycles, typical of normal trickling filter operations, have caused the inside surface of the concrete dome to deteriorate over time. The welded wire mesh reinforcement and other rebar is corroded and exposed over most of the inside surface, as seen in the attached photos. As the steel rusts, it expands causing concrete to spall off. For freeze/thaw, moisture and vapor soaks into the inside face of the dome during warm temperatures, but then experiences freezing temperatures from the exterior during winter which causes freezing and concrete spalling.

The dome appears to have been poured from the bottom to the top in multiple lifts of concrete pours. Construction joints and/or cold joints were created when fresh concrete cured next to concrete that had already begun to cure. The cold joints allow more moisture ingress and more freeze/thaw cycles to the concrete. 'Latitude' lines of deterioration can be seen on the inside of the cover at the cold joints. The holes in the dome are also located at cold joints.

Welded mesh rebar has lost concrete cover. Two holes in the concrete cover can be seen with light coming through between the two light fixtures.

1. Take one trickling filter offline at a time.
2. Prep and protect media and trickling filter distribution mechanism.
3. Pressure wash and/or abrasive blast the inside surface of the concrete
4. Patch all holes and significant spalls with concrete or grout mix.
5. Coat the entire inside surface of the concrete dome.
  - a. It is not recommended to do spot coating because leaving exposed edges of coating allow moisture to travel behind the coating and cause failure of the coating.
6. Based on further review and if deemed necessary apply exterior moisture sealer or coating to prevent moisture from traveling through cover and impacting new interior coating.

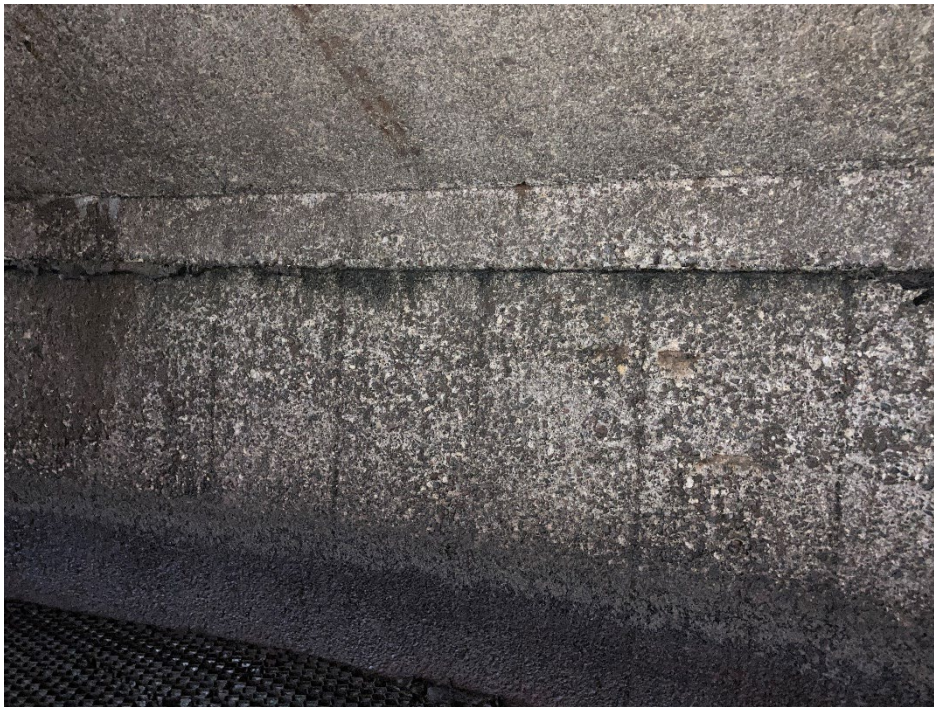
The concrete walls have also experienced surface deterioration in the wet and corrosive environment. However, the amount of deterioration is not as significant compared to the dome and no rebar is showing. Therefore, the walls are not an area of concern for the immediate future.

Trickling filter walls have experienced surface deterioration but are in better condition than the dome.

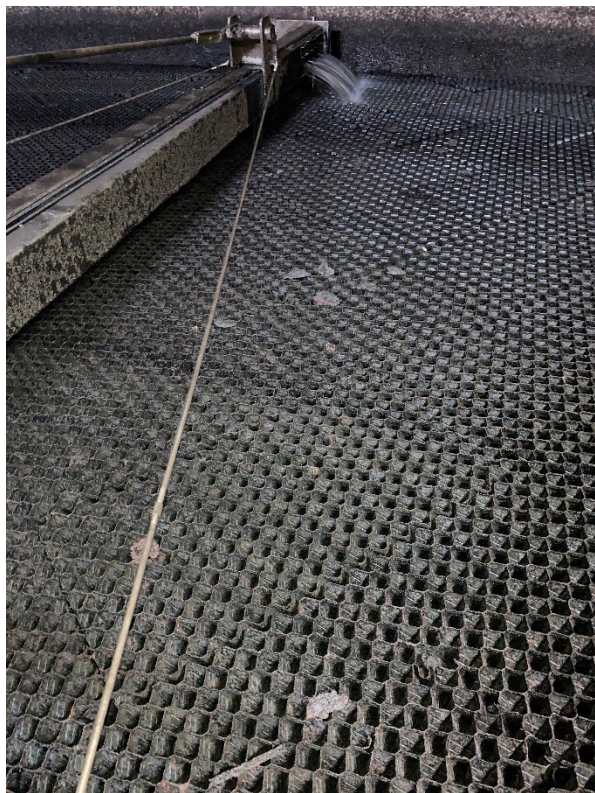
As the rebar continues to corrode and the concrete experiences more freeze/thaw cycles, more concrete will spall. This deterioration will occur in an exponential fashion. Based on the existing condition, SEH believes the cover has approximately 2 to 3 years of useful life without any intervention.

(Left) Small chunks of concrete from the dome have fallen onto the trickling filter media. (Right) Welded mesh and #4 ring rebar has lost concrete cover.

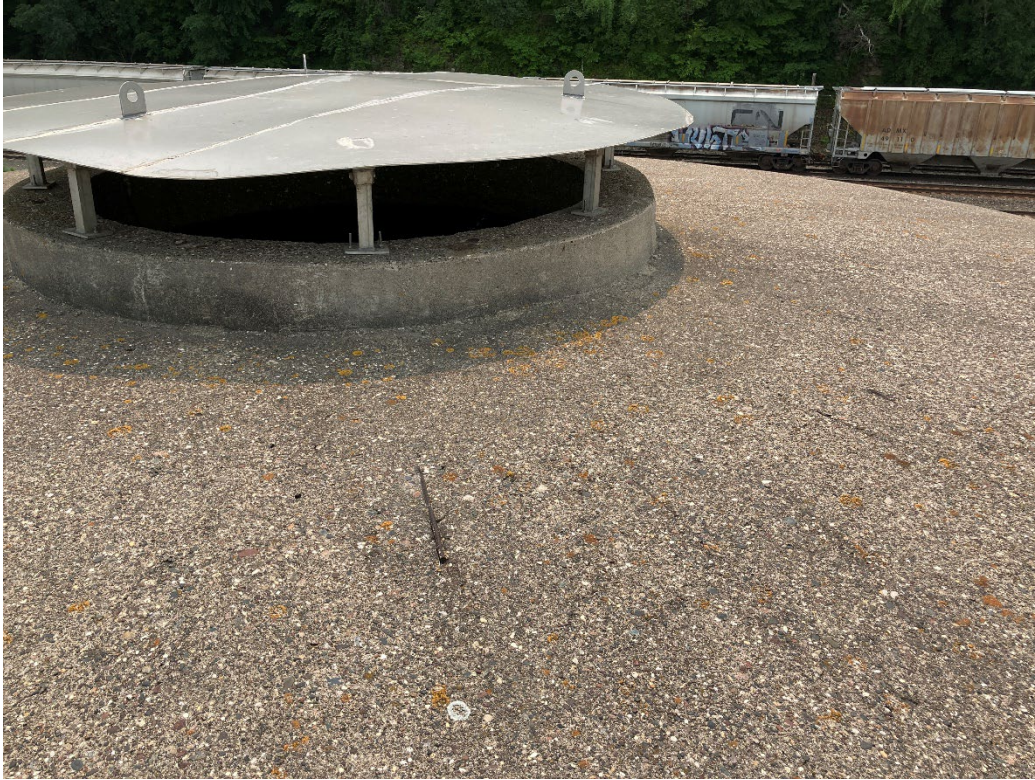
The exterior face of the concrete domes are in relatively good condition for 60 years of service life. #4 radial rebar have lost cover and are exposed.

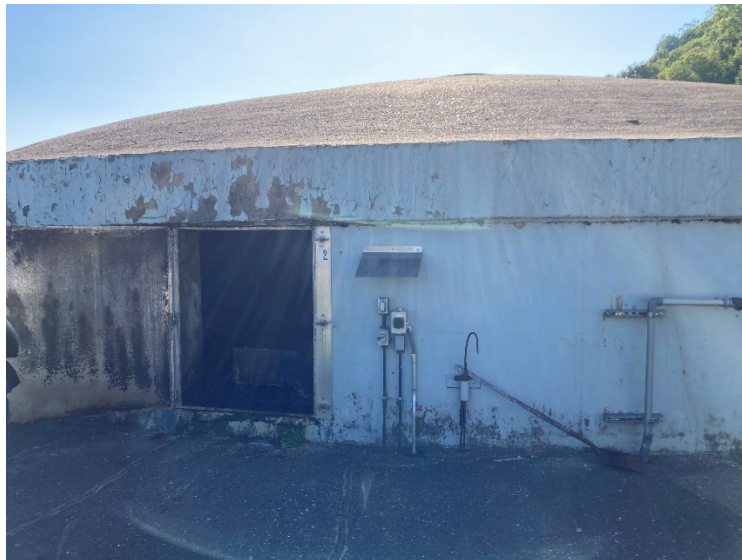
The exterior trickling filter walls have experienced less surface deterioration.
