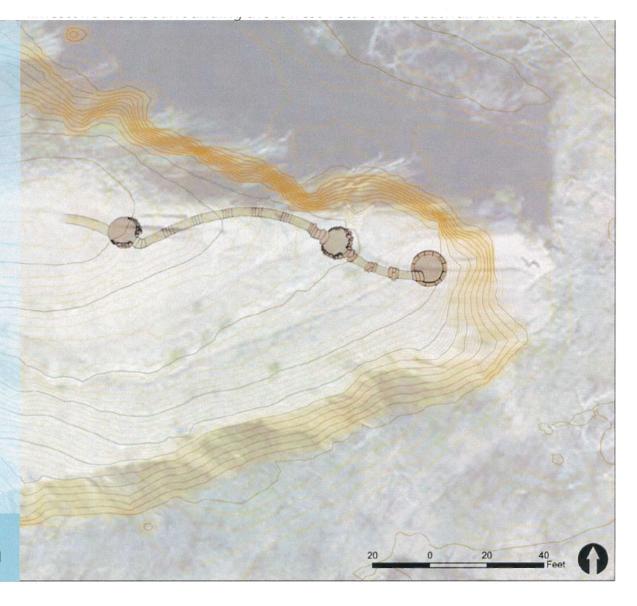
FIGURE 3.4
EAST OVERLOOK IMPROVEMENT AREA PLAN

- » Steps combined with sloped grades help to traverse the terrain
- » Existing trail realigned to better accommodate grade changes and prevent continued erosion
- » Limestone steps transition to natural stone blocks as the final overlook approaches
- » Boulders interspersed with prairie grasses frame the first two vistas, providing a visual edge without requiring railings
- A circle of limestone blocks defines the final overlook. This area is held back
 slightly from the cliff edge, so there's no immediate drop below
