GATE VALVE BOX
ALIGNMENT DEVICE

PLATE NO.
2-03

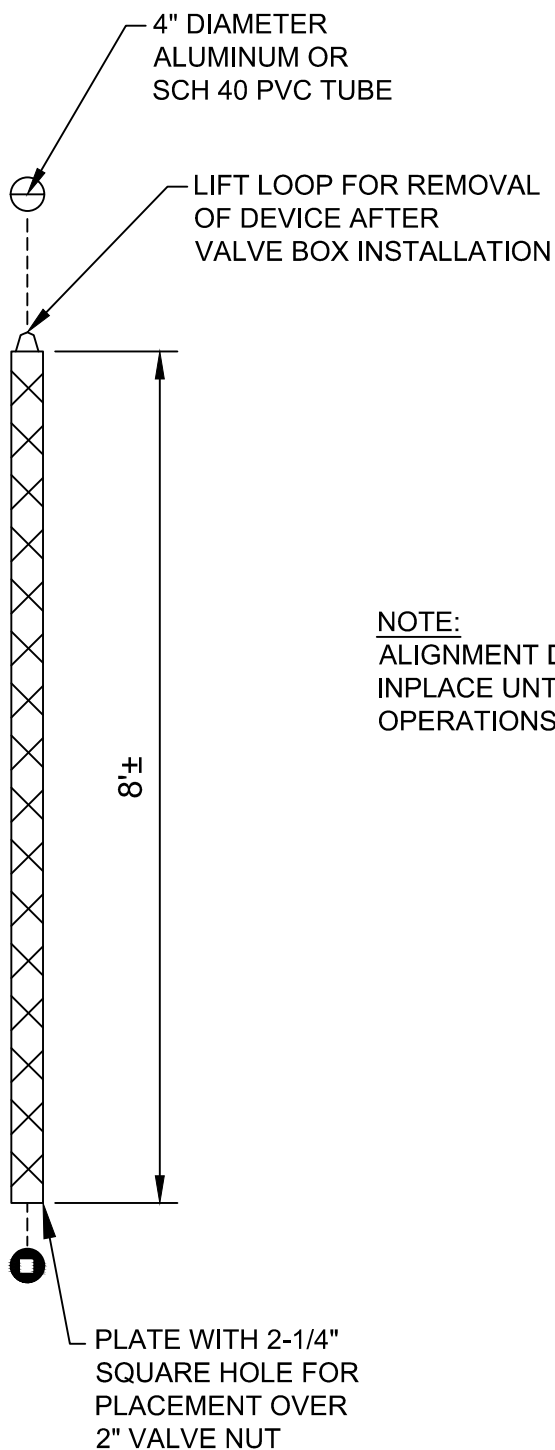
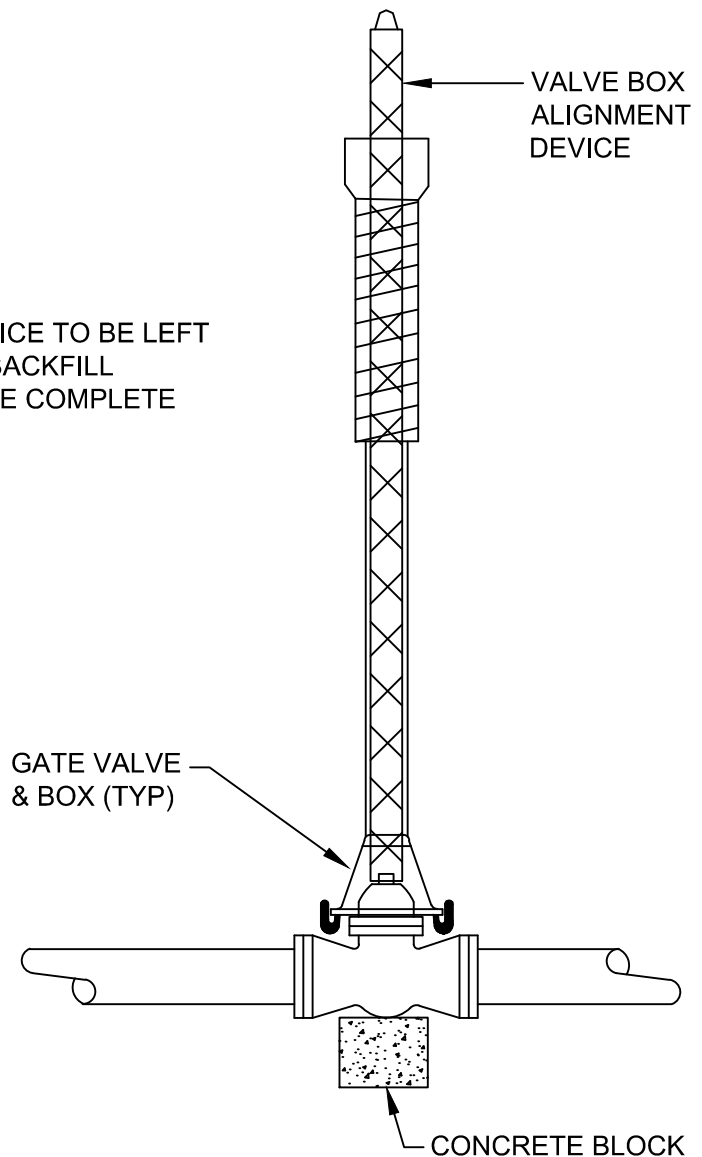
NOTE:
ALIGNMENT DEVICE TO BE LEFT
INPLACE UNTIL BACKFILL
OPERATIONS ARE COMPLETE
